Early Morning Shocked

By AM1(AWISW) Robert Brooks,
VFA-151 Safety Petty Officer

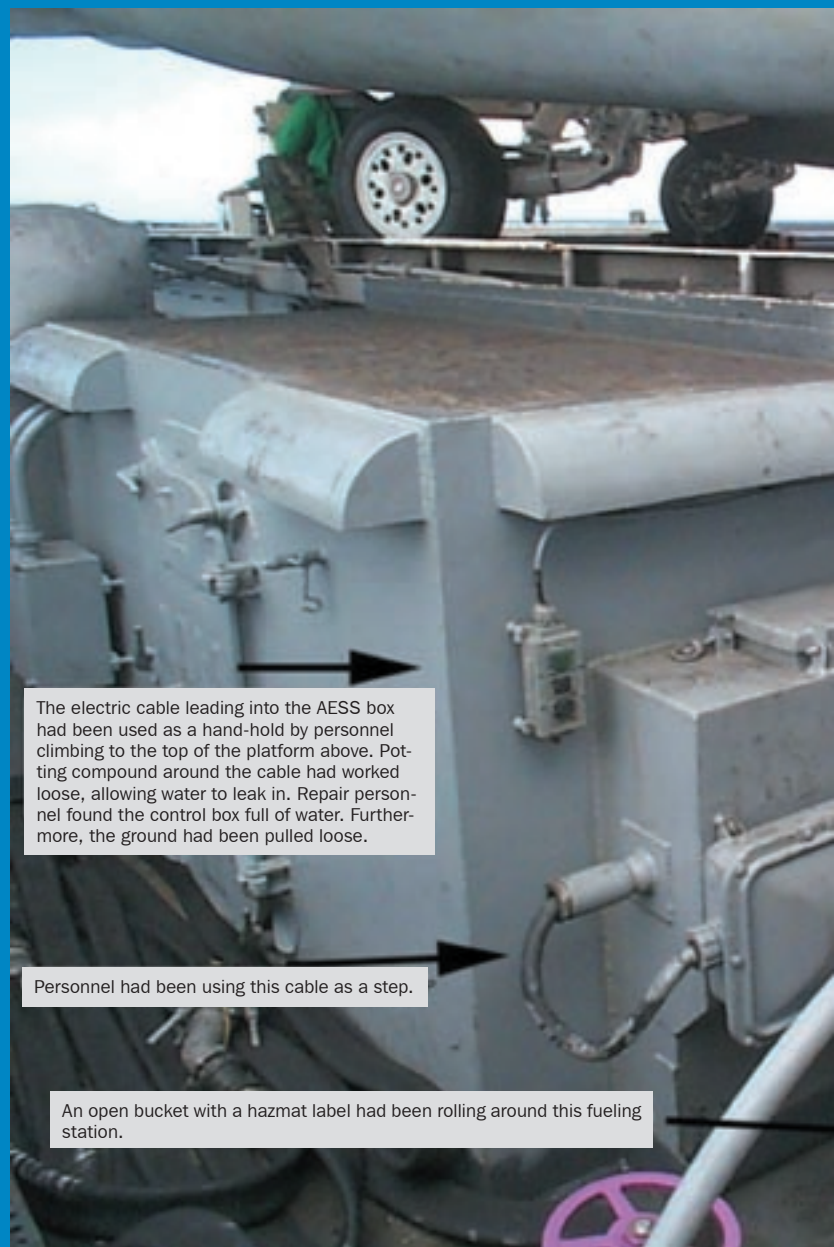
The AESS controller box wires had not only been loosened and the ground connection broken

after the bundle was continuously grabbed when Sailors climbed to the flight deck. Using the wire as a handgrip had also loosened the potting compound designed to keep moisture from seeping into the box. When the grounding-wire finally came loose,

the controller box casing became “hot” and when our AOAN touched it, he completed the circuit to ground.

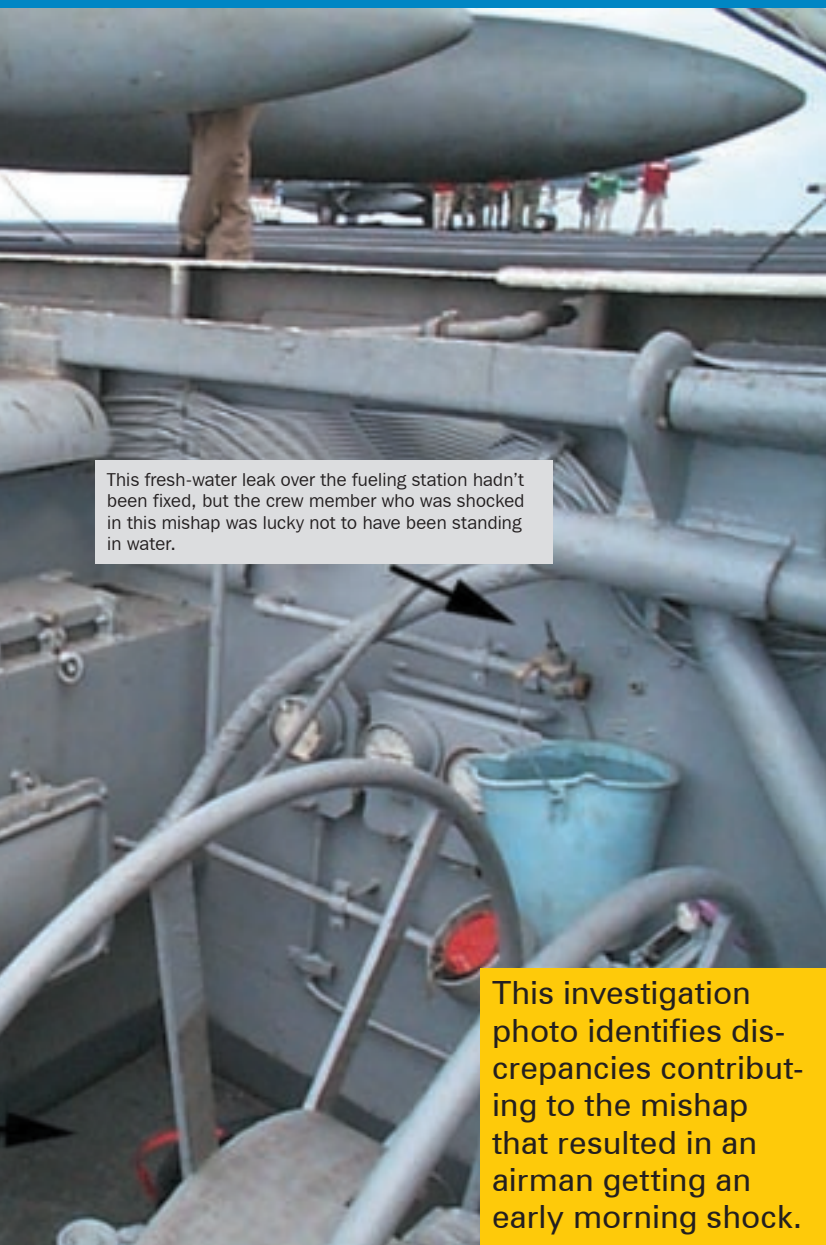
This fresh-water leak over the fueling station hadn't been fixed, but the crew member who was shocked in this mishap was lucky not to have been standing in water.

This investigation photo identifies discrepancies contributing to the mishap that resulted in an airman getting an early morning shock.
